### Cleanroom **Certification Report**

Ameridose 697 Waverly Street Framingham, MA 01702

March 06, 2008

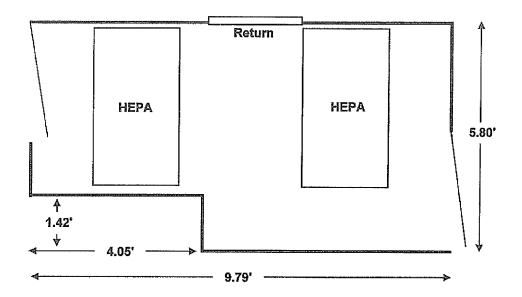
Freight Ante Room

Return	And the second s		
Sliding Door				Sliding Door
	161	184	166	119
	105	204	183	249
	Charles and the charles and th

AT .5 MICRONS AND LARGER						
Area(ft²)	80	# of	High L	ocation.	Avg.	of Loc.	95%	UCL	ISO
Area(m²)	7.43	Locations	ft³	m³	ft <sup>3</sup>	m³	ft³*	m³	Class
		8	249	8,793	171	6,052	202	7,139	7
ISO Target	7	*ISO Class 7 allows a maximum of 352,000 particles 0.5 microns and larger per cubic meter average count at any location as long as the entire clean area meets the required statistical *For comparison the calculated values are presented in both cubic feet and cubic meter							
Class	1							cubic meter	
		*The 95%UCL calculated for cubic feet uses the FS209E UCL Factors.

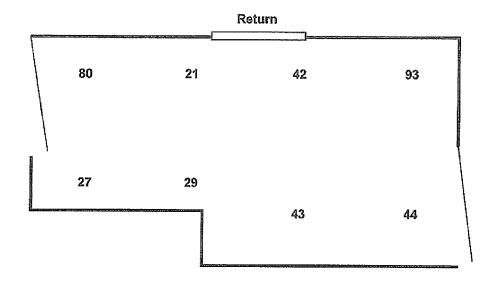
#### Peoples' Ante Room

AT .5 MICRONS AND LARGER							
Area(ft²)	64	# of	High I	Location	Avg.	of Loc.	95%	6 UCL	ISO
Area(m²) g	5.95	Locations	ft <sup>3</sup>	m³	ft <sup>3</sup>	m³	ft³∗	m³	Class
		8	93	3,284	47	1,673	64	2,285	7
ISO Target	7	* ISO Class 7 allows a maximum of 352,000 particles 0.5 microns and larger per cubic meter a average count at any location as long as the entire clean area meets the required statistical to							
Class	1	*For comparison the calculated values are presented in both cubic feet and cubic meters.							
		*The 95%UCL calculated for cubic feet uses the FS209E UCL Factors.

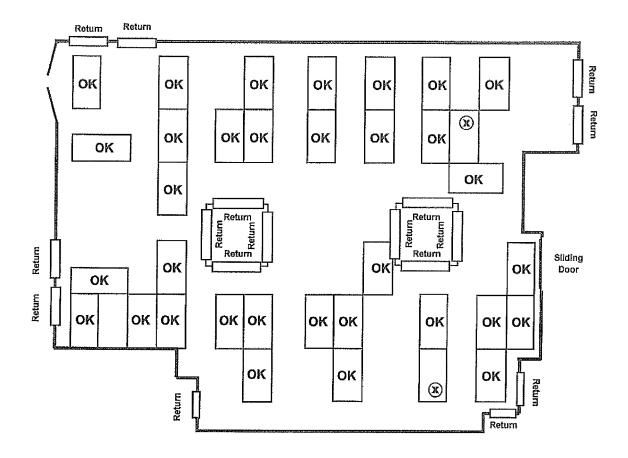
#### Main Cleanroom

Note: Two HEPA filters found damage and repaired.

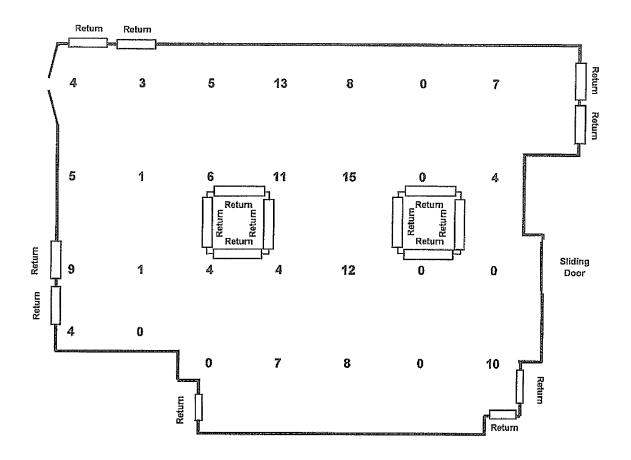
#### **Main Cleanroom**

Area(ft <sup>2</sup> ) Area(m <sup>2</sup> )	998 92.72	# of Locations	High L ft <sup>3</sup>	A ocatio
		28	15	530
JSO Target	5	* ISO Class 5 allows count at any		
Class	ð	* For compar	ison the c	aiculate
		* 177-	e 95%H0	Lealer

Avg.	of Loc.	95%	UCL	ISO
m³	ft <sup>3</sup>	m³	ft <sup>3</sup> *	m³	Class
530	5	178	N/A	N/A	5
